## ONLINE PARTIAL DISCHARGE MEASUREMENT AS A PREDICTIVE MAINTENANCE TOOL OF MOTOR AND GENERATOR STATOR WINDINGS

Soetjipto Soewono<sup>1</sup>, Better Pasaribu<sup>2</sup>

PLN Institute of Technology

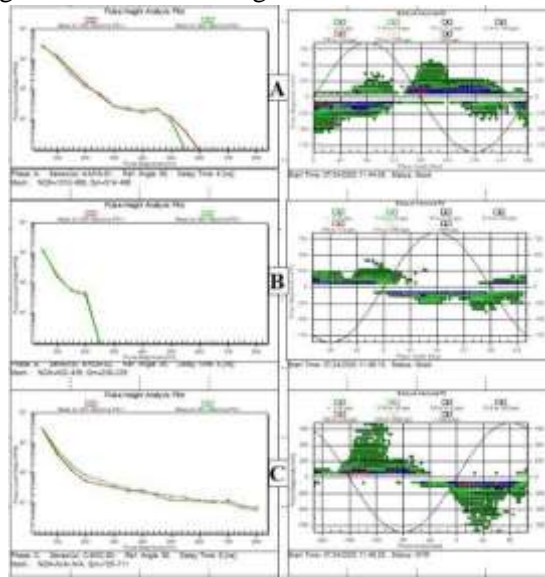
Figure 3. Distribution of Partial Discharge Pulses for phases A, B and C

The three phases exhibit partial discharge characteristics centered at 15°, 75°, 195° and 255° angles, which usually occurs due to the phase voltages at the ends of the stator winding (End winding) as shown in Figure 3 below. The highest measured partial discharge phase C values are Qm+ of 735 mV and Qm- of 711 mV, which is much greater than the average value of Qm in table 2 for the 13-16 kV engine category, which is 184 mV, or four times greater than the average value:

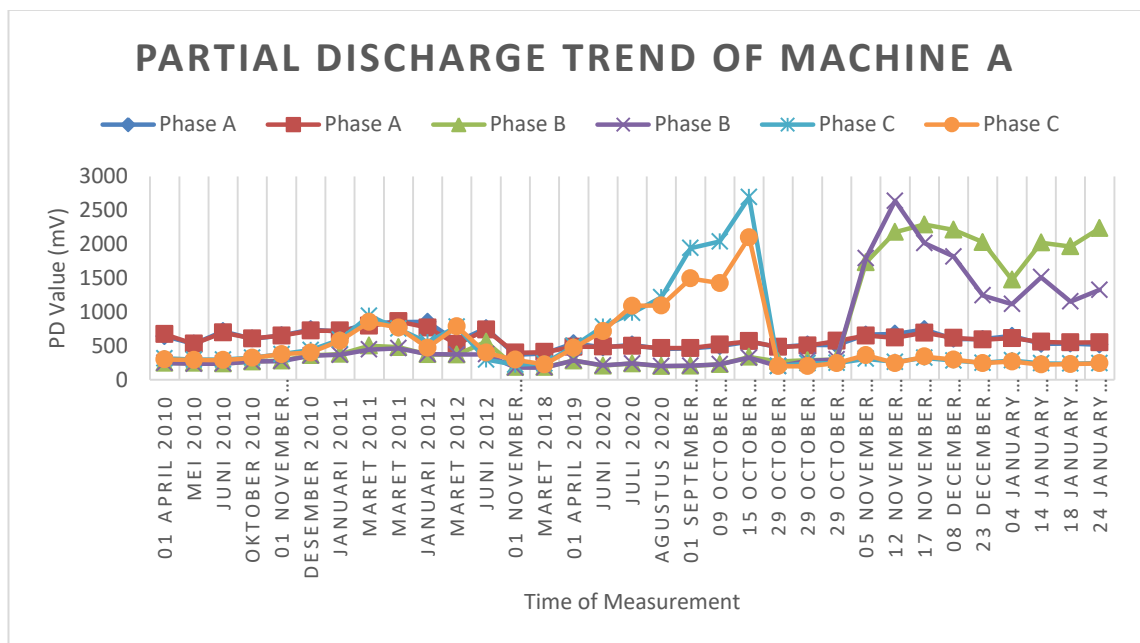
Figure 4. Graph of Partial Discharge Trend of Machine A

The trend of partial discharge generators has been stable for 8 years from the start of its operation in 2010 until 2018. However, phase B partial discharge began to rise in April 2019 and continues to increase as shown in the trend graph in Figure 4

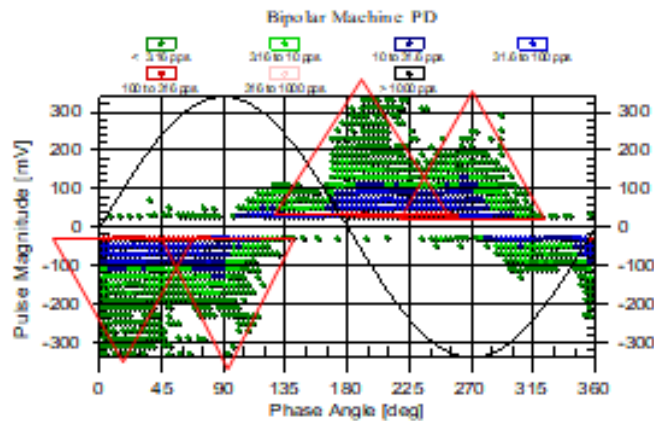
Figure 7. Distribution of Partial Discharge Pulses for phase C

For clarity, the distribution of pulses in phase C can be seen in the partial discharge pattern in Figure 7 with a lower range and a sinusoidal reference for phase C starting at an angle of 0°.

The shape of the pulses centered at 15°, 75°, 195° and 255° angles is very similar to a partial discharge due to contamination problems [3].

The inspection results found oil contamination in the generator end winding section, especially in phase C, due to leakage. After cleaning, it is seen that the partial discharge pulse in phase C has decreased to its initial condition, but after the partial discharge in phase C can be overcome, a partial discharge in phase B appears again, which is similar to phase C.

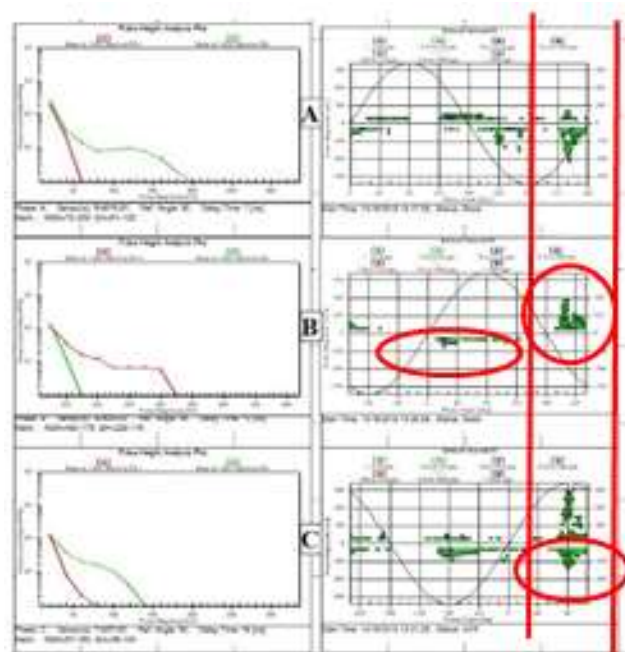
Figure 8. PD Pulse Distribution of Machine B

The partial discharge pattern in Figure 8 shows the highest partial discharge activity in phase B and is centered at the angles of 15° and 195°, which is shifted 30° from the angles of 45° and 225°, thus indicating that the partial discharge occurs in the generator end winding area and occurs between phases. B and phase C, because phase C has the same partial discharge pattern as phase B but with reversed polarity [3].

Visual inspection found evidence of partial discharge between phases B and C in the generator end winding area and in the generator winding connection area which was indeed detected in partial discharge at 0° and 180° angles.

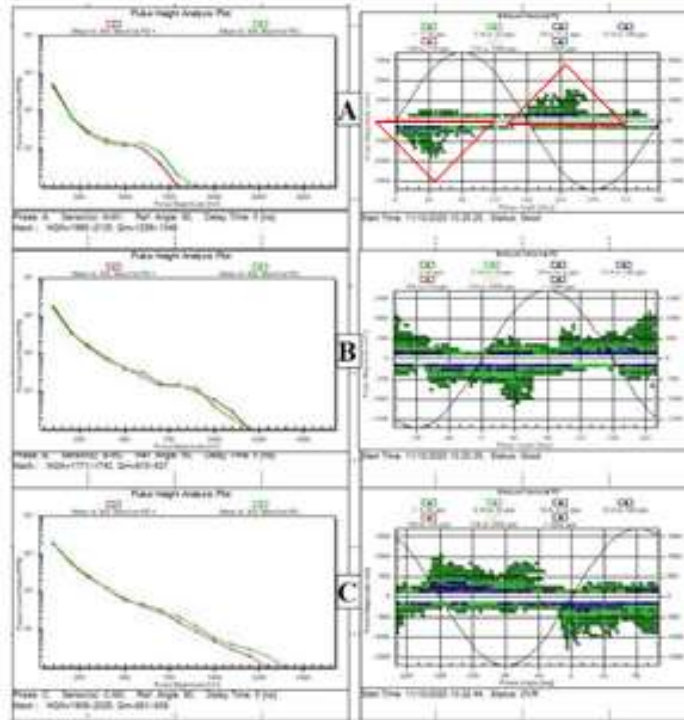
Figure 9. Partial Discharge Pattern of Machine C

The measurement results of the measured insulation resistance for phase A are only 1.5 kΩ, while phases B and C are measured above 1.5 GΩ. This can be said to be consistent with the partial discharge findings, namely that phase A was measured with the highest partial discharge level. The visual findings after the repair process was carried out in the workshop were also consistent with the partial discharge findings in the field, namely in phase A there was a hole in the insulation and melted copper as a result of a

short circuit because there was already a weak point in the motor insulation.

The partial discharge pattern in Figure 9 also shows a correlation which is in accordance with the findings in the field, namely that the three phases exhibit very high partial discharge characteristics centered at  $45^\circ$  and  $225^\circ$  angles, which are usually caused by phase-ground voltages and that occur in the stator winding slot. The partial discharge pattern that occurs with an even distribution of positive and negative pulses is an indication of partial discharge in the stator main insulation or groundwall insulation [4].
