Innovative Investigation and Strategy for Improving the Performance of 70% Alumina Refractory Roofs Against Thermal-Slag Corrosion and Extreme Temperatures in Electric Arc Furnaces (EAF) in the Nickel Matte Production Process

Anggoro Rohadi, Sulistijono, Lukman Noerochim, Sutarsis, Hariyati Purwaningsih

Institut Teknologi Sepuluh Nopember, Indonesia

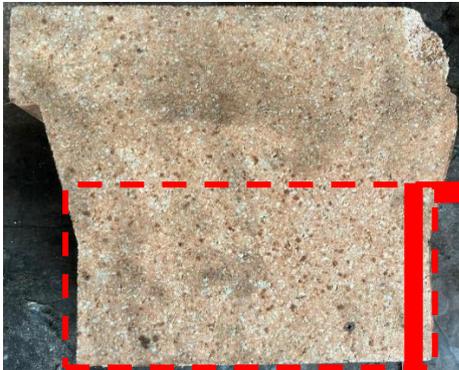
(a) Surface view

The *new refractory* sample is a representation of the brick in its whole state as shown in Figure 2.a, while the red highlight box is an illustration of the brick part that is lost due to damage after use. Refractory brick undergoes a change where the bottom is covered with a blackish-brown layer as shown in Figure 2.b and Figure 2.c. Observations of the blackish-

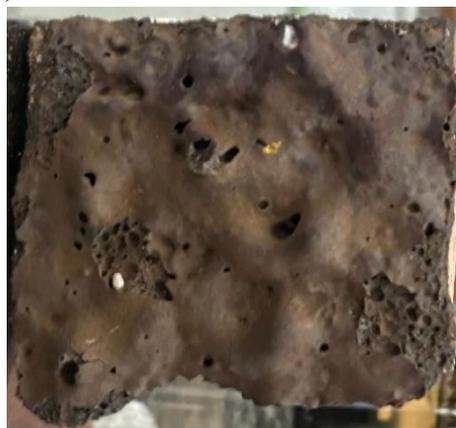
(d) visible refractory bottom

brown layer showed that the part was uneven and porous (Figure 2.d), so further observation and analysis of refractory brick failures were needed.

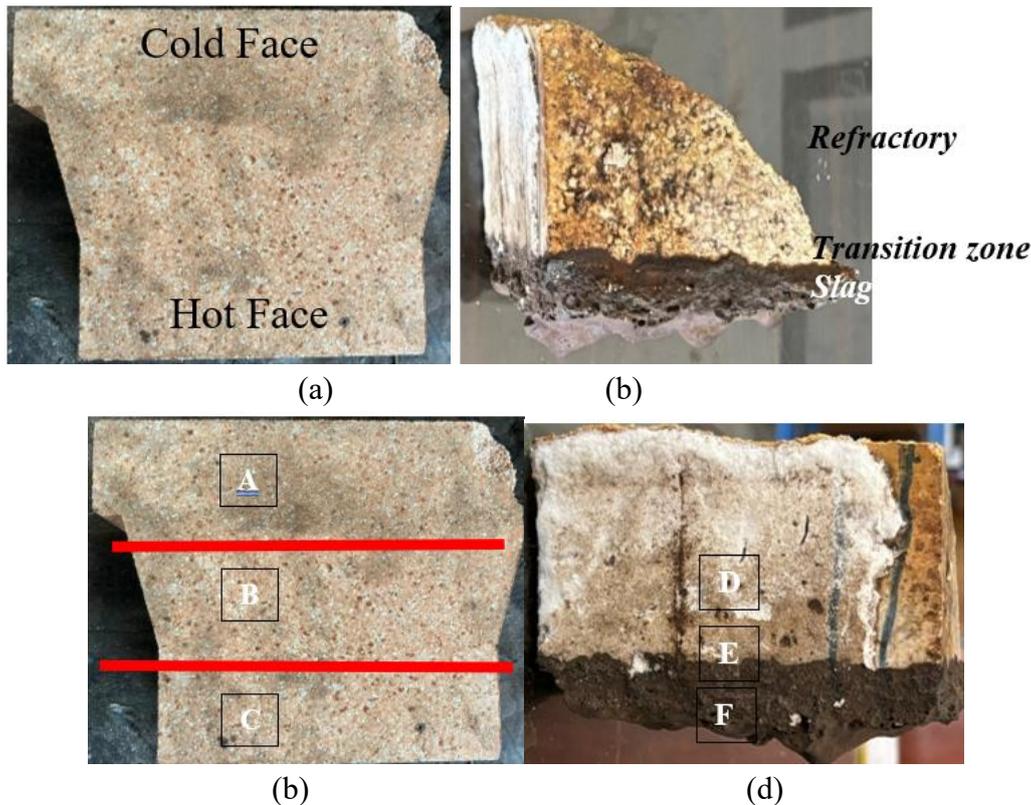
Figure 3. Visual Characterization and Zoning of New and Used Refractory Degradation

- (a). New Refractory Sample – Transverse Appearance
- (b). Used Refractory Samples – Identification of Degradation Zones
- (c). Zoning A–C for New Refractory XRD Analysis
- (d). D–F Zoning for Used Refractory XRD Analysis

Visual observations of the used refractory refractories show significant structural degradation, especially on the side of the refractory that is directly exposed to the process environment. The change in color from pale beige to dark gray to brownish-black indicates oxidation, metal diffusion, and contamination of the process material. Three main zones can be clearly identified:

1. The Intak Refractory Zone, a part of the refractory that remains solid and homogeneous, resembles the initial condition without significant visual damage.
2. The Transition Zone, undergoes a discoloration and begins to show micro-cracks, texture changes, and softening due to partial chemical reactions.
3. Slag Zone, a refractory surface that is in direct contact with *slag*; appears partially melted, cracks widespread, and highly porous. This surface also experiences the accumulation of metal residues and scale.

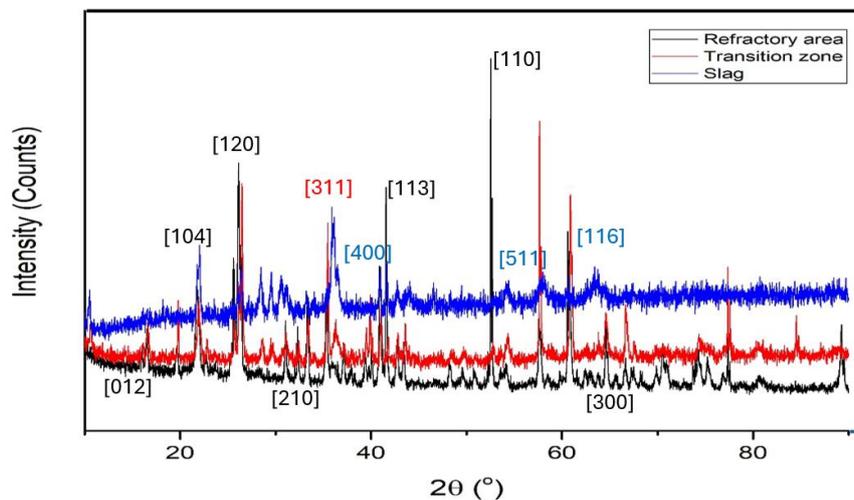
Figure 7. XRD Test Results on Sample Used Refractory in Refractory area (Black), transition zone (red) and Slag zone (blue)

The results of the x-ray diffraction test on the refractory used sample are shown in Figure 7. The diffraction pattern shows that there are several differences in diffraction peaks in each test sample, these differences lead to differences in compounds/phases identified as part of the qualitative analysis. Qualitative and quantitative analysis using High-score plus analysis software is shown in Table 5.

The results of XRD in the transition area also showed a radical change. The mullite content shrinks drastically to 18%, while corundum drops to 13%, signaling partial dissolution by the molten phase of slag. The decomposition of mullite gives rise to sillimanite (27.8%) and moganite (16.5%), recrystalline silica phases that indicate thermal and chemical imbalances. At the same time, spinels begin to form: $MgAl_2O_4$ reaches $\sim 7\%$ and $FeAl_2O_4$ $\sim 6\%$, totaling about 14%. The presence of potassium aluminum silicate ($\approx 8.7\%$) indicates alkaline infiltration of slag, while cristobalite drops to 2.6% due to the dominance of new corrosive phase formation. This zoning marks the region where bricks begin to lose grain integrity and the bonds between crystals weaken.

In the slag area, the primary structure is almost completely eroded. Mullite remains 21.5%, while corundum practically vanishes. Spinel grew rapidly to 21.3% (divided by 9.5% Mg-spinel and 11.8% Fe-spinel), while the corrosive silicate phase took over: calcium aluminum oxide ($Ca_5Al_6O_{14}$) by 23.9% and magnesium aluminum silicate hydrate ($Mg_2Al_4Si_5O_{18} \cdot 0.54H_2O$) by 19.1%. Cristobalite also rose again to 8.7%, marking the transformation of silica to an amorphous/glassy form. The combination of expansive spinel and brittle silicates creates a matrix that is low cohesion and prone to cracking.

Overall, the evolution of the composition from the refractory area to the slag area maps the path of degradation: the initiation of spinelization reactions at the grain border, followed by the corundum/mullite dissolution by the molten phase of the slag, and finally the accumulation of the brittle phase on the most exposed surface. This transformation is driven by high temperatures ($> 184\text{ }^\circ\text{C}$) and diffusion of Fe^{2+}/Mg^{2+} ions, resulting in volumetric expansion that triggers microcracks. The daily heating-cooling cycle then doubles the crack into macroscopic spalling. These results confirm that design interventions—whether anti-spinel-coated brick formulations or roof geometry adaptations—are indispensable to reduce the rate of degradation and extend the service life of EAF refractories.

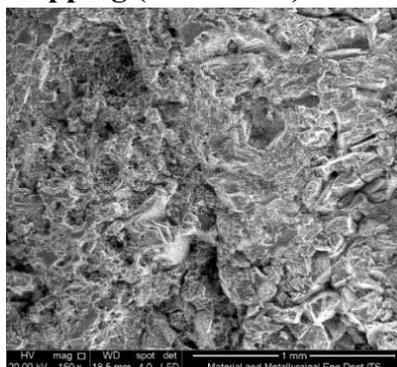
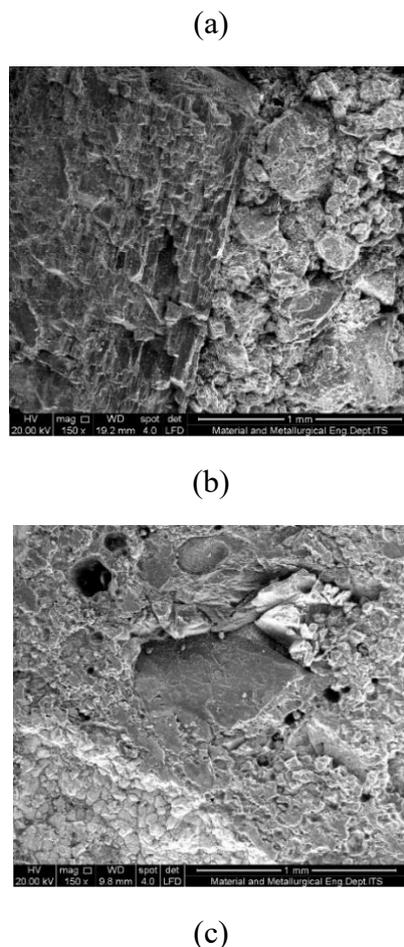
Figure 8. Comparison of Microstructures in Used Refractory Brick

(a) Refractory Area, (b) Transition Zone and (c) Slag Area

SEM/EDX testing is performed on samples used refractory for further analysis to determine changes in the microstructure and distribution of chemical composition. Figure 8 is a summary of the comparison of microstructures in three areas used refractory. Figure 8 (a) shows the microstructure for the refractory area, the grain size becomes smaller but still shows the homogeneity of the microstructure. Figure 8 (b) shows the transition area, where there is a difference in the refractory and slag boundary areas. The left side correlates with the refractory microstructure while the right side corresponds to the refractory area slag. The microstructure in the slag area of Figure 8(c) shows a heterogeneous particle size. Specifically, in each area used refractory, EDX composition analysis and specific observations were carried out as shown in Table 6.

Based on EDX data, it can be explained that used refractory bricks have a different chemical composition. In the refractory area, the composition still shows the suitability of the composition with the new refractory, this shows that even in the used sample, degradation does not occur simultaneously. A review of the transition area shows that the chemical composition changes as the position changes.
