## Evaluation of Occupational Safety, Health, and Environmental Aspects in the Use of Geofoam on Clay Shale Soil as an Alternative Embankment Material

*In the Cisumdawu Toll Road Construction Package 5A, at the STA 40+125–STA 40+225 area, soil material cannot be used for embankment work because the existing soil condition is clay shale. This study aims to evaluate EPS geofoam material as a substitute for soil material because it is lighter and safer from the aspects of occupational safety, occupational health, and the environment. This study uses a qualitative research design with a descriptive method, with data collected from 13 informants ranging from staff-level employees to management among the work implementers. The data were obtained through interviews with informants and observations conducted both in the field and via related documents. The data analysis techniques applied include data collection, data reduction, data presentation, and conclusion drawing with verification. The results of this study show that unstable clay shale soil, which is not strong enough to withstand the embankment load, causes cracks and landslides; HSE risk management for handling cracks and landsl

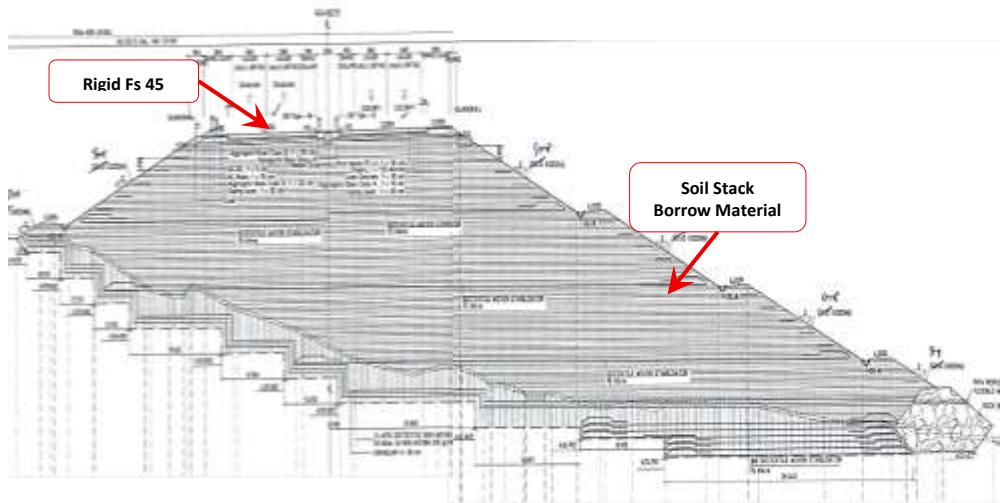
Figure 2. Initial Design Drawings of STA 40+125 – STA 40+225

Based on the research conducted, the occurrence of cracks and avalanches in STA 40+125 – STA 40+225 is caused by the existing soil condition in the form of clay shale soil that is unstable and cannot accept the load of soil piles as in the initial design. As stated by one of the informants in the following interview, "The hoarding of the 40+200 sta pile work is carried out as usual per layer (per layer about 30 cm thick, according to the -red-specification), but the conditions at that time tend to rain more often, because the area (sta 40+200) is a low point (valley area / lowest point -red), so that the area becomes saturated with water. When the pile approaches the top sub grade (the limit of the pile -red), cracks occur and form a crown on the road body with the exit direction away from the Centre Line (shifted from CL: the middle area of the work -red). And the crown that occurs is also followed by a decrease in the elevation of the pile."

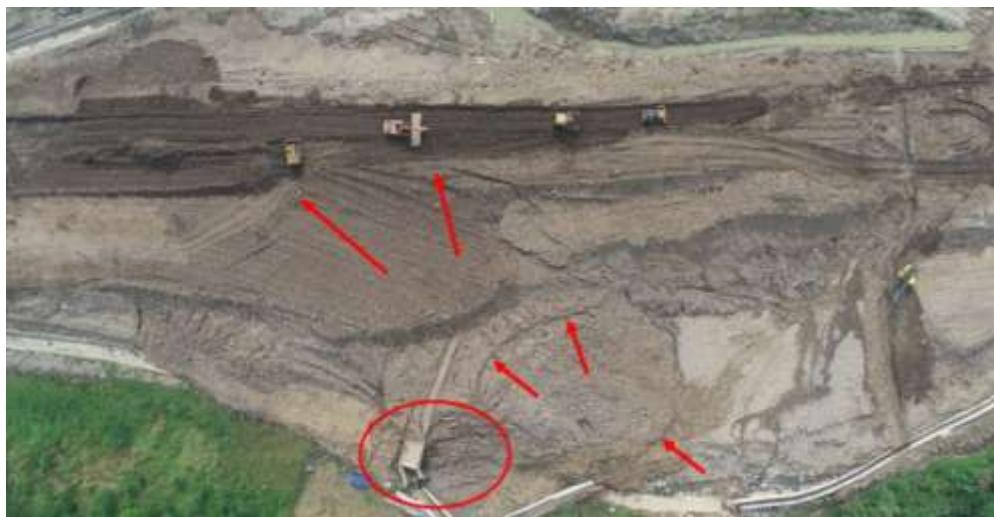
**Figure 3 Cracks in STA 40+200**

From the observations and information obtained (both from interviews and other related data), compared to the literature / expert opinion (Soehatman Ramli, Paulus Rahardjo, PT. Geotechnical Engineering Consultant), the researcher argues that cracks and avalanches in STA 40+125 – STA 40+225 are caused by subsoil conditions that are unable to withstand the load of the heap. Plus the high rainfall factor which can increase the load significantly. If the hoarding work continues, it will be more dangerous from the aspect of work safety because the safety of workers is threatened and can cause even bigger landslides. In addition, the continuity of the organization/company becomes threatened because it can have an impact on the potential for greater losses and the company's image which can be bad.

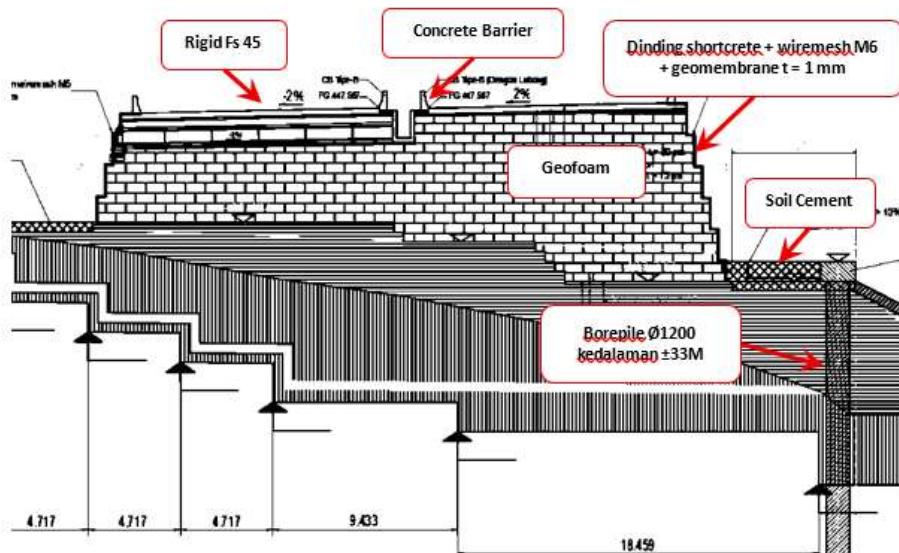
**Figure 4. Handling Using Geofoam**

From observations and information obtained (both from interviews and other related data), compared to the literature / expert opinion (Soehatman Ramli, Fahmi, PT. Geotechnical Engineering Consultant, and also PT. Adhi Karya), the researcher argues that the risk management of avalanche handling that does not exist at the beginning of the implementation of the work is due to the absence of the necessary information and detailed data. This has been equipped with a Geofoam Job Safety Analysis, as soon as there is a new design, namely using geofoam.

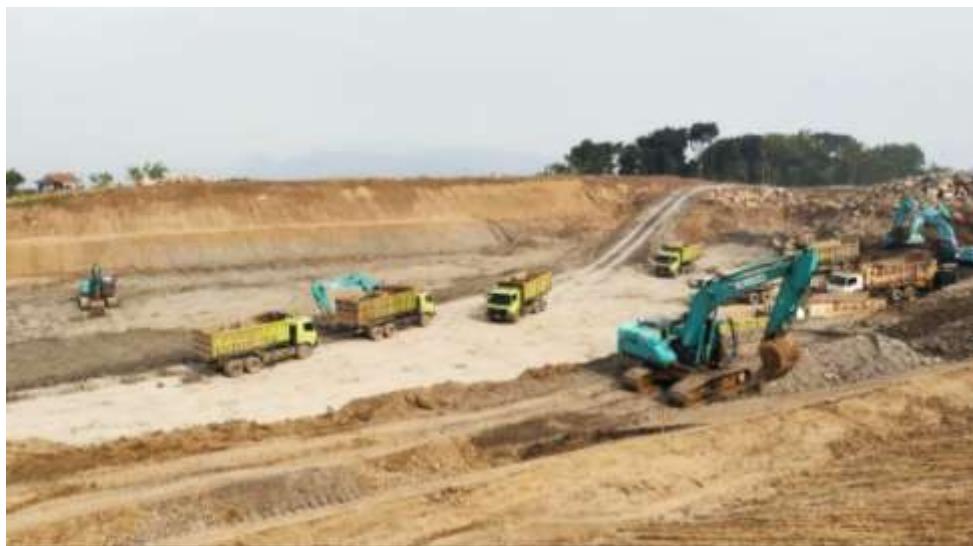
**Figure 5. Landfill Work**

Based on the research conducted, the selection of geofoam has advantages in terms of occupational safety. The use of geofoam does not require heavy equipment or dump trucks (DT). With conditions like this, the potential for work accidents is greatly reduced due to the absence of heavy equipment traffic at the work site. As stated by one of the informants in the following interview, "The initial design with conventional soil piles used a lot of heavy equipment, of course, the potential for work accidents was many as a result of human error. The final design, because this is a new method and at that time we were unfamiliar with it, there were still many uses of existing heavy equipment to be a tool and mobilize a lot of labor. This has the potential to cause many work accidents. After the work is over (in the first shipment of geofoam material), we have time to evaluate the way it works, where the use of heavy equipment is much reduced, so that the potential for work accidents can be minimized. As an illustration for the use of tools, during the implementation of earthenware work, the needs of tools at this location are:

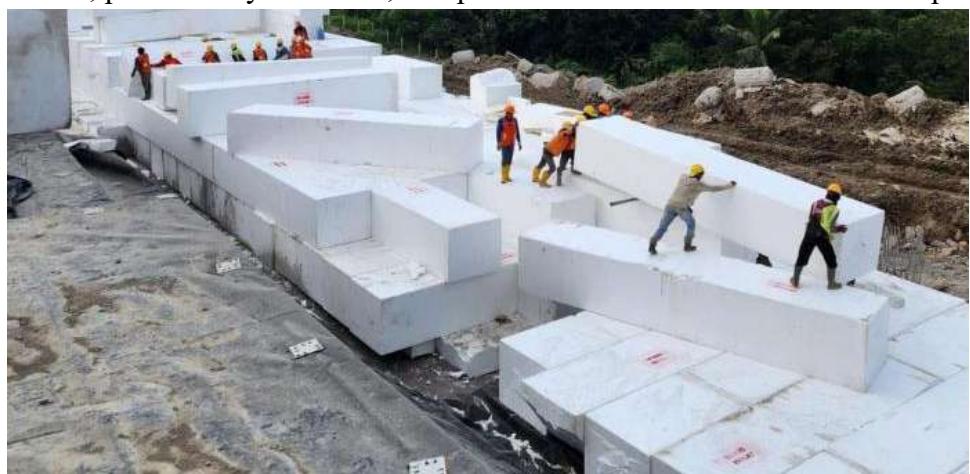
**Figure 6. Geofoam Jobs**

From observations and information obtained (both from interviews and other related data), compared to the literature / expert opinions (Suma'mur, Soehatman Ramli, Anthony Gunawan, Andrawan), researchers argue that the use of geofoam can minimize the potential for work accidents. This is because the implementation of geofoam work does not require a lot of heavy equipment so that the potential for work accidents is smaller. With the potential for minor accidents, productivity increases, and potential cost and time losses can be prevented.

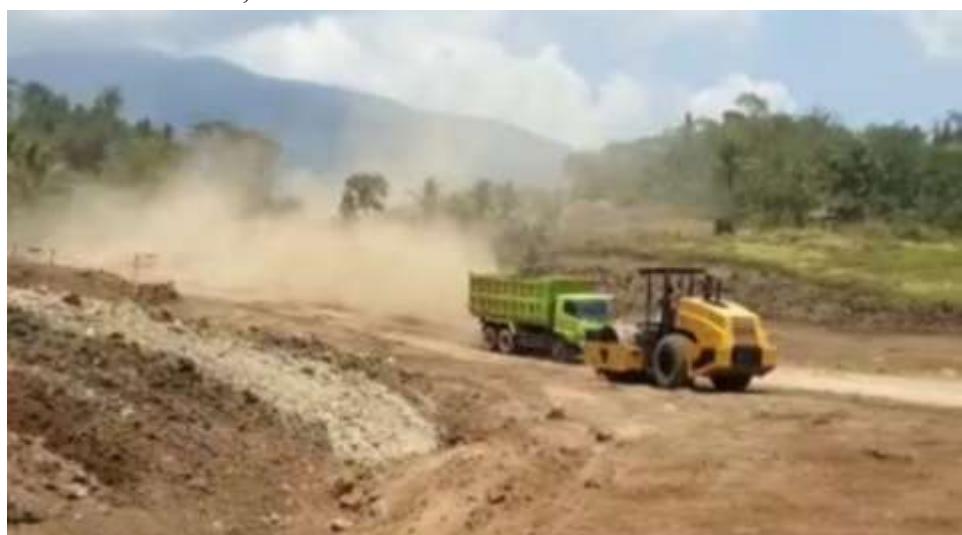
**Figure 7. Dust from Land Transport Mobility**

Based on the research conducted, geofoam has advantages in the aspect of occupational health. The use of geofoam does not use heavy equipment much. The number of heavy equipment is greatly reduced because the use of geofoam affects the health level of workers. At the time of the implementation of the geofoam work, there were no complaints of illness, mainly Upper Respiratory Tract Infection (ISPA) from staff and workers who were routinely active in the area. This is due to the absence of earthworks activities. While the landfill work is still ongoing, the movement of heavy equipment, the mobility of trucks has an impact on the production of dust, both dust from soil materials and from vehicle smoke. This is in accordance with an interview with one of the informants, namely, "The resource (resource -red) of the equipment used for the STA 40 + 200 earthmound work (in the initial design before the occurrence of cracks and landslides – red) is a minimum of 20 dump trucks (DT) index (load volume -red) of 22 m<sup>3</sup> per day. To achieve the production target, each DT must reach the target of 3 ritase per day (number of loads/transport). In the new design, the use of geofoam does not require the use of DT. Trucks as transportation are used only when mobilizing geofoam materials from the workshop to the work site. From the number of DT needs, it has been seen that the potential for work-related diseases will decrease significantly. There are no more DTs crossing from the quarry to the work site. The dust or smoke generated from DT traffic will be greatly reduced. Meanwhile, dust / smoke is the main source of the cause of ISPA."

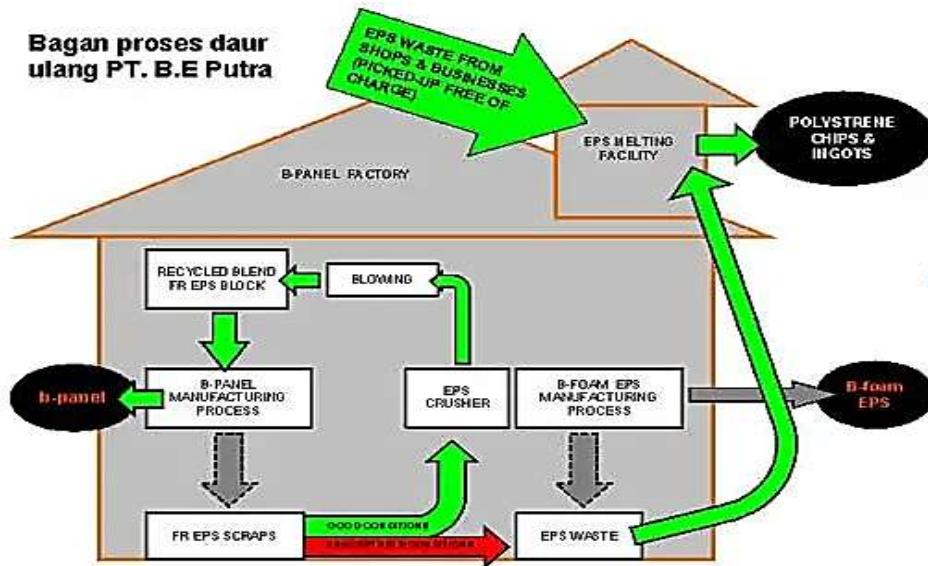
**Figure 8. EPS Material Recycling Process Drawing**

This is in accordance with Gunawan's opinion, 2024, that the installation of geofoam does not require compaction, unlike traditional soil heaps. Therefore, the use of geofoam instead of traditional landfills is more environmentally friendly, reducing CO2 emissions from heavy equipment. One of the main advantages of EPS geofoam is its ability to be recycled without the need for chemical processes, making it environmentally friendly (Andrawan, 2025). EPS waste from the factory is taken to the EPS smelting site, where EPS waste is melted using a specially designed kiln, then molded into hard polystyrene in the form of chips or ingots. These polystyrene chips and ingots are used as raw materials for other products, for example to be used as mobile phone cases, computer cases, and others (Properti.biz b-panel, 2010).
