## ONLINE PARTIAL DISCHARGE MEASUREMENT AS A PREDICTIVE MAINTENANCE TOOL OF MOTOR AND GENERATOR STATOR WINDINGS

Soetjipto Soewono<sup>1</sup>, Better Pasaribu<sup>2</sup>

PLN Institute of Technology

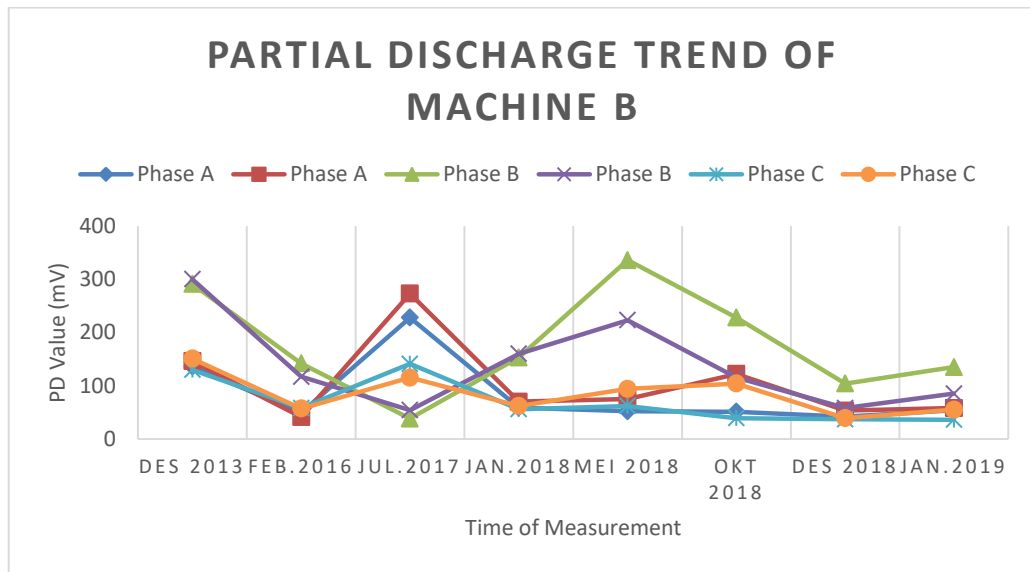
Figure 5. Partial Discharge Trend of Machine B

The inspection results found oil contamination in the generator end winding section, especially in phase C, due to leakage. After cleaning, it is seen that the partial discharge pulse in phase C has decreased to its initial condition, but after the partial discharge in phase C can be overcome, a partial discharge in phase B appears again, which is similar to phase C.
