Innovative Investigation and Strategy for Improving the Performance of 70% Alumina Refractory Roofs Against Thermal-Slag Corrosion and Extreme Temperatures in Electric Arc Furnaces (EAF) in the Nickel Matte Production Process

Anggoro Rohadi, Sulistijono, Lukman Noerochim, Sutarsis, Hariyati Purwaningsih

Institut Teknologi Sepuluh Nopember, Indonesia

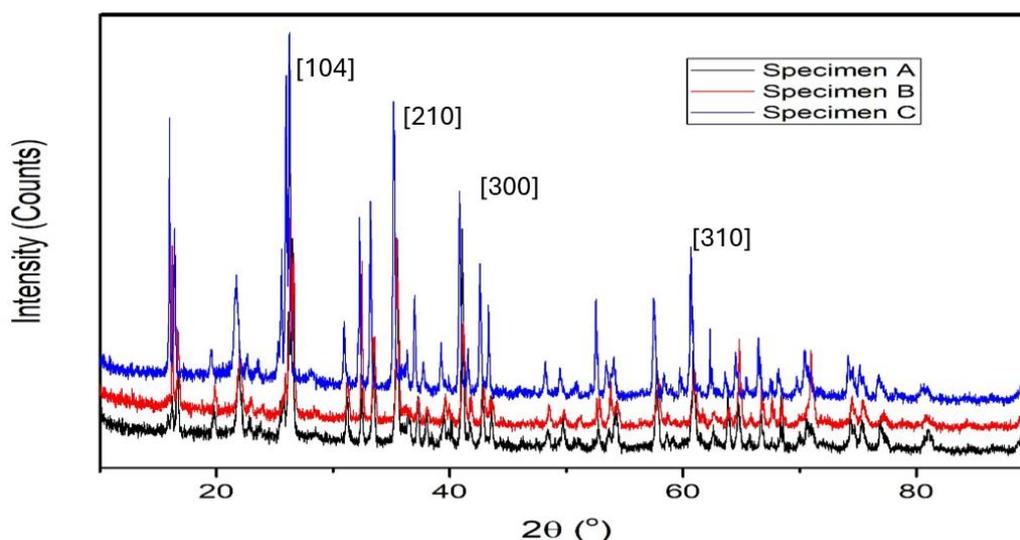
Figure 4. Plot of the diffractogram of X-ray diffraction test results on a new refractory specimen,

Crystalline phase analysis using XRD provides information about the mineral structure present in the new refractory. The results of the XRD test showed the presence of main phases such as mullite (54.9%), sillimanite (30.4%), corundum (11.8%), and cristobalite (2.9%), as shown in Table 2.

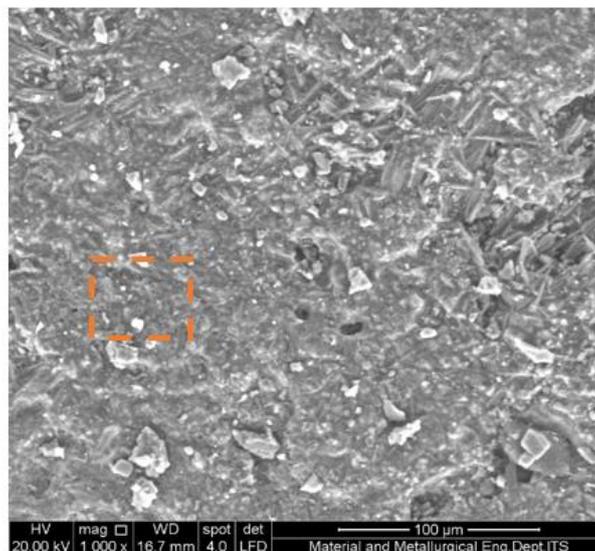
Figure 5. Photo of *the new refractory microstructure*

Overall, the microstructure for *the new alumina brick* sample showed a homogeneous structure, showed no cracks between grains and did not have large pores (Figure 7). The homogeneity of microstructure and chemical composition in the new alumina *refractory brick sample* is supported by mapping data as shown in Figure 8. The elements Al, Si, O are evenly distributed on the surface, along with the supporting chemical elements in the form of Ca, K and Ti are scattered in the matrix. While the element iron (Fe) is scattered in the matrix, but there are also groups at the grain boundary, but the chemical composition is relatively low overall.

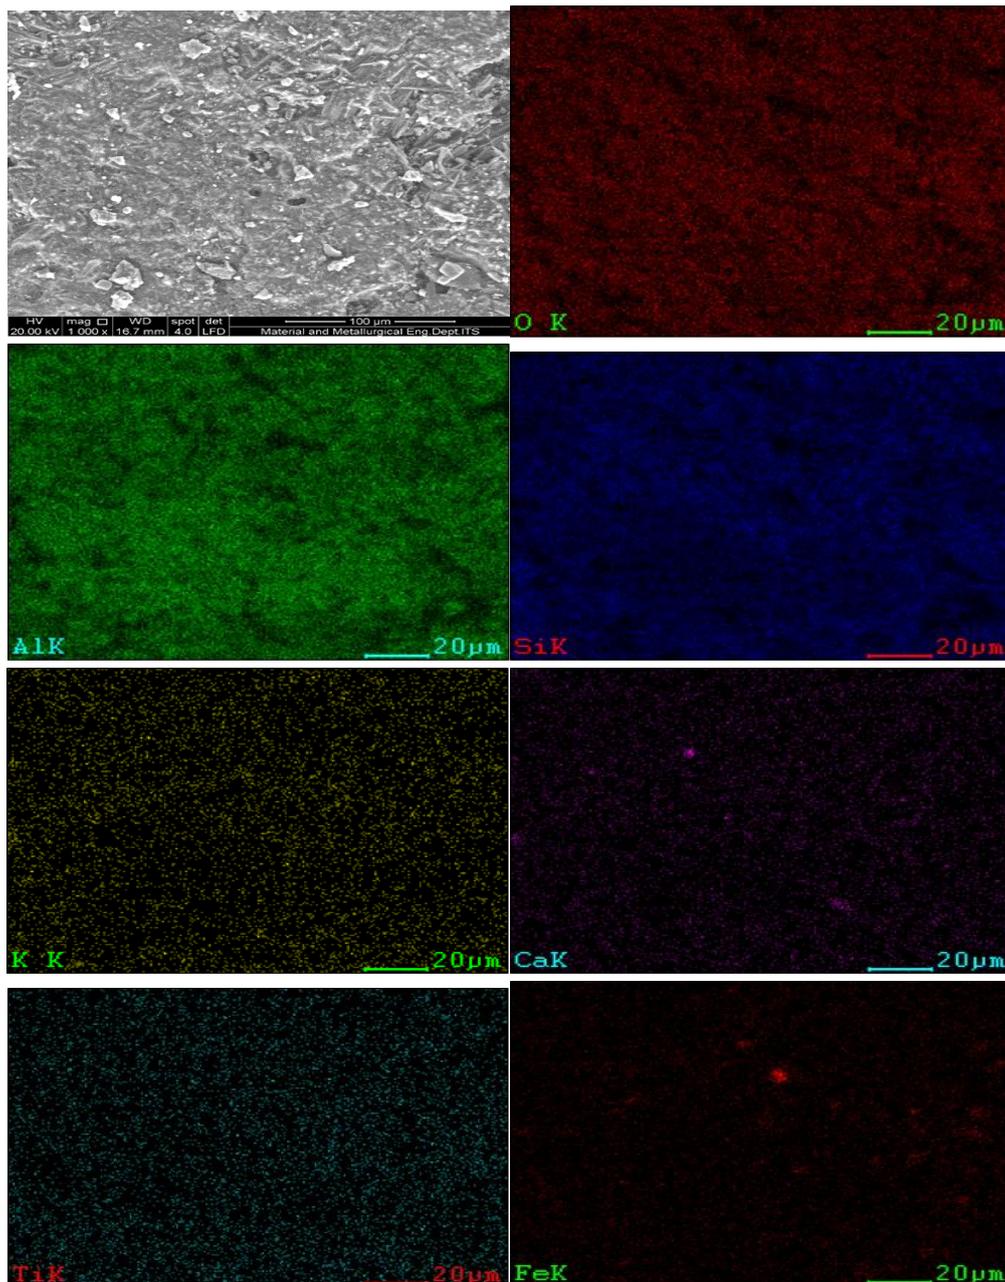
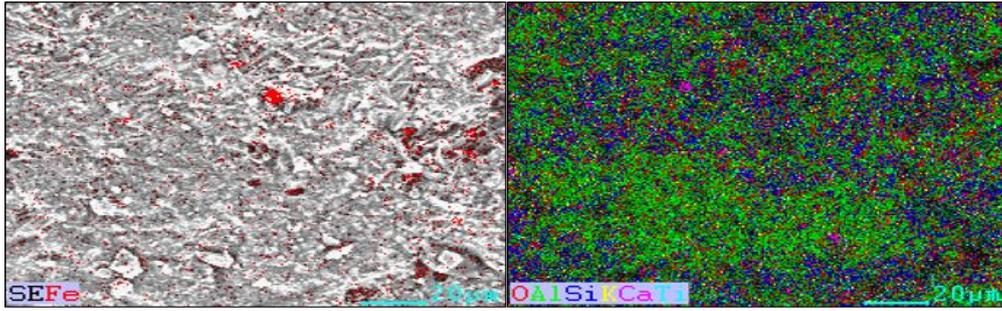
Figure 6. Results of mapping chemical composition in *a new refractory brick sample*

The results of the SEM-EDX analysis show that this new refractory material has a composition consistent with alumina-silicate-based materials. The predominance of aluminum, oxygen, and silicon elements across the analysis points suggests that the main phase of this material is a combination of corundum (Al_2O_3), mullite ($3\text{Al}_2\text{O}_3 \cdot 2\text{SiO}_2$), and possibly *glassy phase*. The difference in the content of Fe and other minor elements between the analysis points summarized in Table 3 indicates the existence of a microstructural heterogeneity that is common in refractory materials.

This variation in composition also indicates that during the sintering process, local phase segregation occurs which causes the distribution of minor elements to be uneven. The presence of minor phases such as FeAl_2O_4 or other complex oxides can affect the refractory resistance to corrosion as well as thermal loads, which should be considered in the analysis of refractory performance during furnace operation.
